# Technical Evaluation Motor No. 7 (TEM-7) Final Test Report

## **April 1991**

### Technical Evaluation Motor No. 7 (TEM-7) Final Test Report

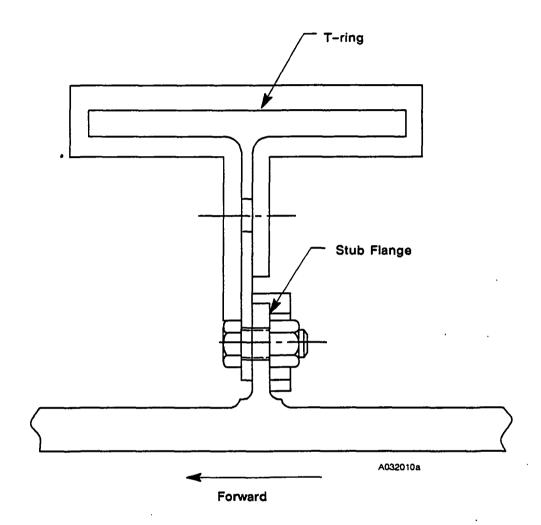
Figure 6-2. TEM-7 T-ring Configuration

The motor was equipped with a stiffener T-ring assembly on the flanges which had the severed outer ligaments. The T-ring is known to help reduce flange stresses, thus reducing concerns generated by the severed outer ligaments. This is also representative of the flight configuration (Figure 6-2).

TEM aft segments should have T-rings installed on stiffener stubs with known outer ligament cracks to minimize risks associated with this condition.

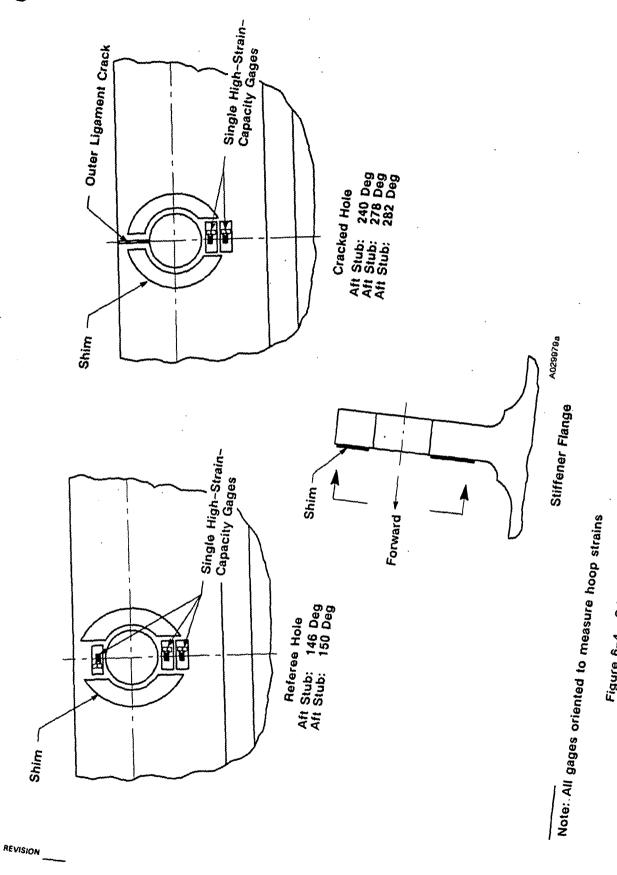
Figure 6-4. Stiffener Stub Outer Ligament Cracks and Instrumentation

Both flanges of the aft stiffener cylinder (1U50185-06, S/N 027) have outer ligament cracks:

Instrumented outer ligament cracks and instrumented referee holes are illustrated in Figures 6-3, 6-4, and 6-5.

The TEM-7 static test provided an opportunity to gain information concerning the behavior of stiffener stub outer ligament cracks during an actual motor firing. Thiokol Corporation has decided not to allow RSRM stiffener case segments with outer ligament cracks into the flight rotation. This decision was based in part on a lack of knowledge about the structural effect of the severed outer ligament on the T-ring/case assembly. In an effort to help fully understand this interaction, the

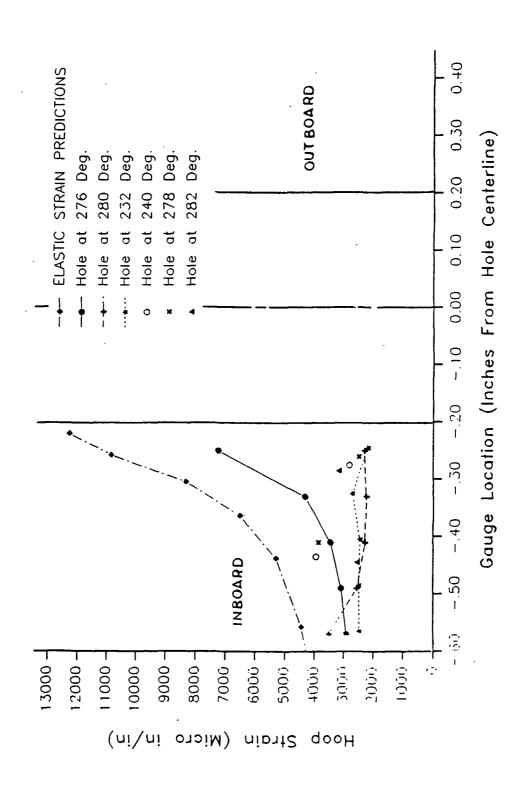
Figure 6-12. Measured Versus Predicted Elastic Stiffener Flange Strains (hoop)-Cracked Outer Ligament

The instrumented stiffener stub hole strain gages all recorded data except for the lone referee strain gage mounted inside a stiffener stub hole. There was a large variation between measured and predicted strains at holes with outer ligament cracks. Measured strains at holes with intact outer ligaments correlated well to predicted strains.

The gages on a number of the severed outer ligament holes resulted in very peculiar output (278, 280, 232, and 240 deg). The strains were very low, compared even with the elastic predictions. Several of these holes also indicated a reverse stress gradient, or, in other words, showed stresses increasing with distance away from the hole. As mentioned in Section 6, Test Description and Results, these gages (as well as all the others) appear to have functioned properly otherwise. This trend, however, does not reflect common engineering experience. There are, as in any test, a number of sources for possible error in the results. Measures were taken, wherever possible, to minimize the variables effecting the results. However, a few sources of error that are worthy of mention in this test are: gage location measurements, the fact that predictions were based on minimum material properties, and gage accuracy.

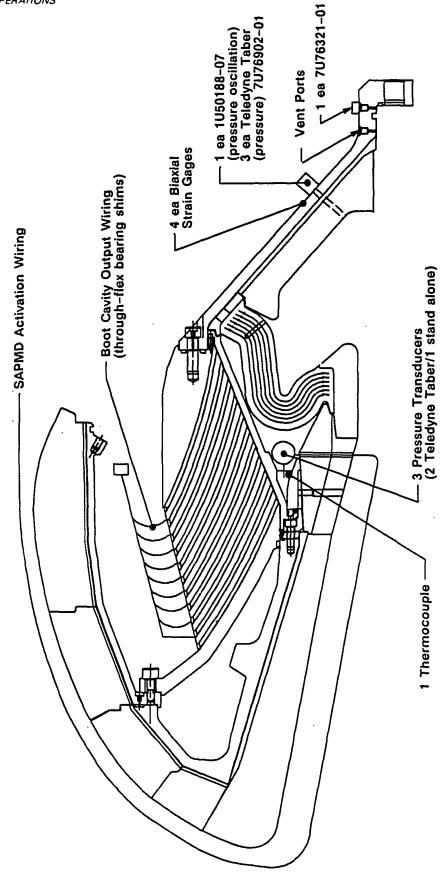
Figure 6-23. Fixed Housing and Boot Cavity Instrumentation

One of two Teledyne Taber pressure transducers recorded data until T + 20 sec then the data became erratic. Software anomaly is believed to have caused both SAPMDs to be inoperable prior to test. The thermocouple data were erratic throughout the firing, but did demonstrate the increased temperature into the boot cavity resulting from increased vent hole diameters. Boot cavity pressure data were obtained by one pressure transducer from T - 0 to T + 20 sec. No data were obtained from three other (two SAPMD and one Teledyne Taber) transducers.

The installed pressure transducers in the boot cavity and thermocouple were erratic. One pressure transducer recorded data until T + 20 sec and the other failed. The thermocouple data were erratic throughout the firing but did demonstrate the increased temperature into the boot cavity resulting from increased vent hole diameters.

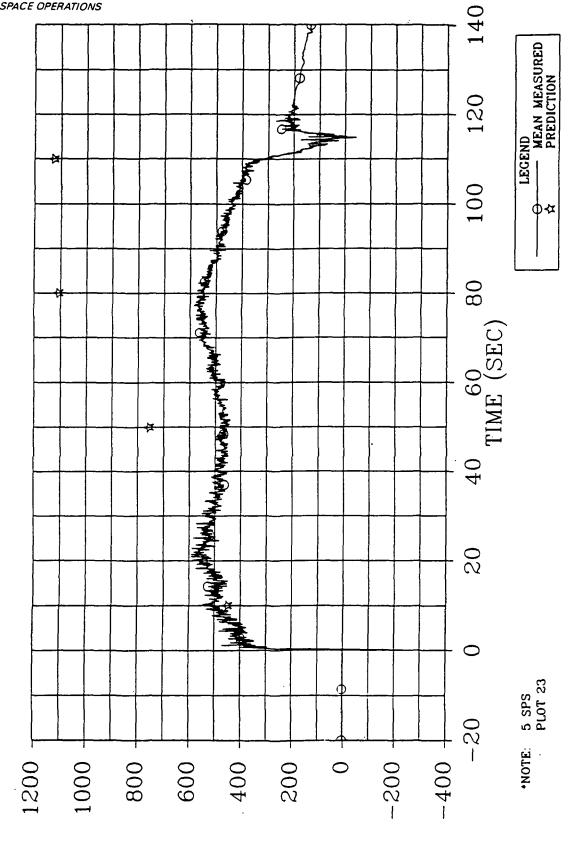
Figure 6-26. Aft Exit Cone Housing Sta 1962.8 Hoop Strain (mean value)

Hoop strain at aft exit cone Stations 1962.8, 1902.2, and forward exit cone Station 1865.0 (Figures 6-26, 6-28, and 6-30) match predicted values for 10- and 20-sec time slices. Subsequent time slices do not match predicted magnitudes as well; however, the strain profile and magnitude are indicative of strains from previously observed test motors. The meridional strain profiles for the same station locations (Figures 6-27, 6-29, and 6-31) match predictions very well. The meridional strain profile at Station 1962.8 is shifted down slightly from the predicted. Gage preload is one possible explanation for this; however, the 100-microstrain shift is negligible.

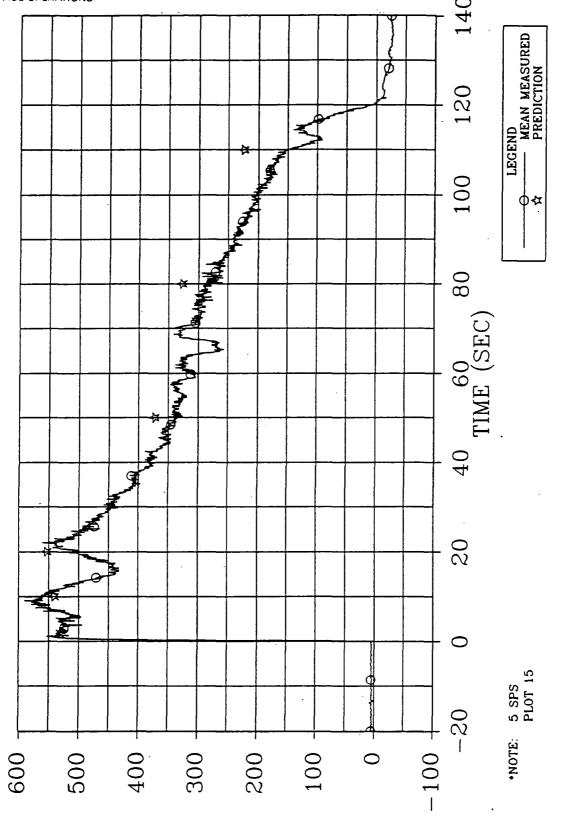
Figure 6-34. Nose Inlet Housing Sta 1842.5 Hoop Strain (mean value)

Strain data from the nose inlet housing aft end (Station 1842.5) was comparable to previous test measurements. Hoop strain (Figure 6-34) matched predictions.

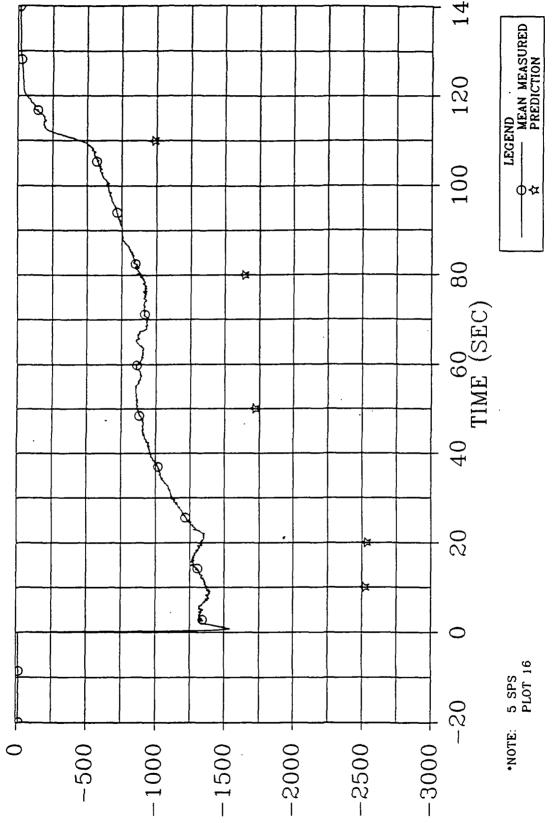
Figure 6-35. Nose Inlet Housing Sta 1842.5 Meridional Strain (mean value)

Meridional strains at Station 1842.5 (Figure 6-35) were less severe than predicted values, which is typical for this location.

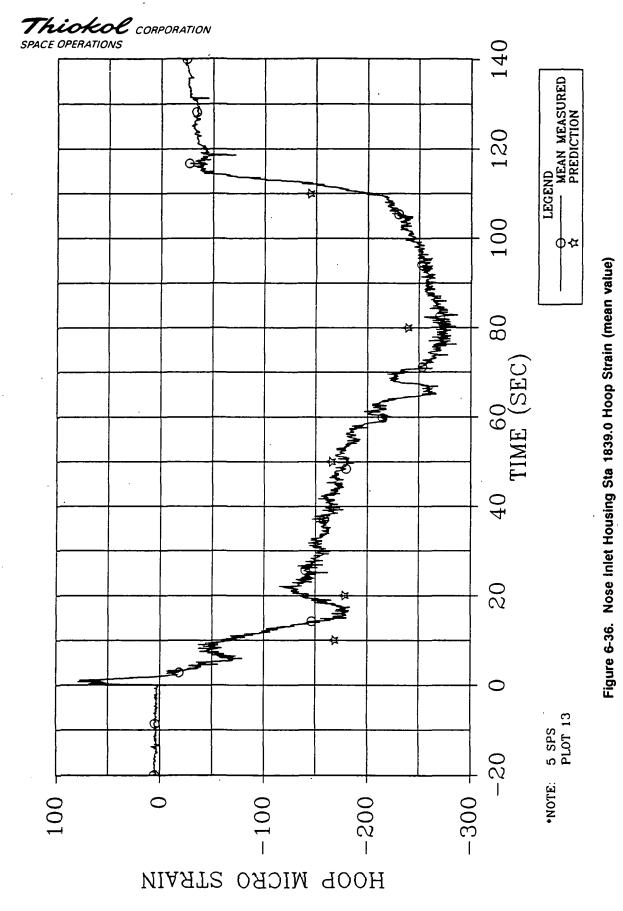
Nose inlet housing hoop strain at Station 1839.0 (Figure 6-36) showed a tensile shift of approximately 60 to 130 microstrain. Hoop strain at this location on the nozzle nose inlet housing is compressive. The shift occurred at ignition and was tensile, which would indicate that the instrumentation experienced a problem not impacting the nozzle hardware itself. Meridional strains at Station 1839.0 (Figure 6-37) matched predicted values.

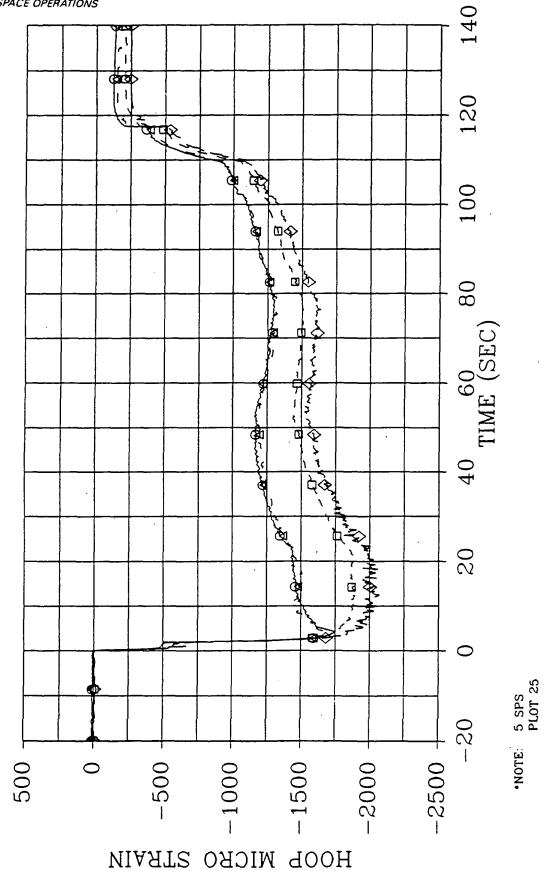
Figure 6-38. Fixed Housing Sta 1867.0 Hoop Strain

Strain data at Station 1867.0 on the fixed housing shows an anomalous occurrence approximately 2 sec into motor burn. Both the hoop and meridional strains (Figures 6-38 and 6-39) increased sharply in magnitude at 2 sec. Extensive structural analysis, fracture mechanics analysis, and postfire observations showed that the EA 913NA adhesive bondline failed between the fixed housing and the GCP insulation. This failure was attributed to contamination of the fixed housing bonding surface coupled with the four pressure transducers installed through the fixed housing (test configuration only). This configuration created both a stress concentration and a gas path to the adhesive bond interface. Predicted strains at the gage location, prior to 2 sec, match TEM-7 measurements; also, predicted strains with pressure in the bondline match the strain data after 2 sec (Figures 6-40 and 6-41).
